Subject: Saab 9-4X Water Leak at Driver or Front Passenger Floor Area and or Front Carpet Wet

Models: 2011 Saab 9-4X

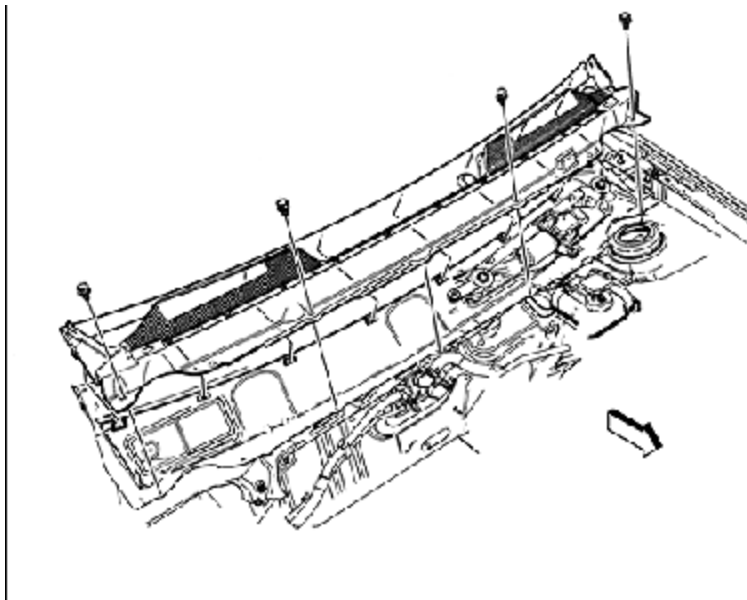
Some customers may comment on seeing a water leak in the driver or front passenger floor area and/or finding the front carpet wet. The two most common causes of this concern are that there may be a void in the cowl seam sealer, in the corners below the sunroof drain hose grommets, or that the front sunroof drain hose or grommet may not be fully seated in the cowl panel.

1. Remove the air inlet grille panel. Refer to Air Inlet Grille Panel Replacement in WIS.
2. Inspect that the front sunroof drain hose grommets (1) are fully seated to the cowl on both sides. If necessary, re-seat by pushing the grommet into place from the vehicle interior.
3. If you find that the drain hose grommets are not fully seated, ensure that the sunroof drain hoses are not misrouted or too short, by completing the following steps:
 - 3.1. Remove the A-pillar trim. Refer to WIS 9-4x / 2011 / Body / Sunroof / Adjustment/Replacement / Sunroof Housing Front Drain Hose Replacement
 - 3.2. Check the drain hoses for tension that may tend to cause a future disconnect or unseating of the grommet.(3)

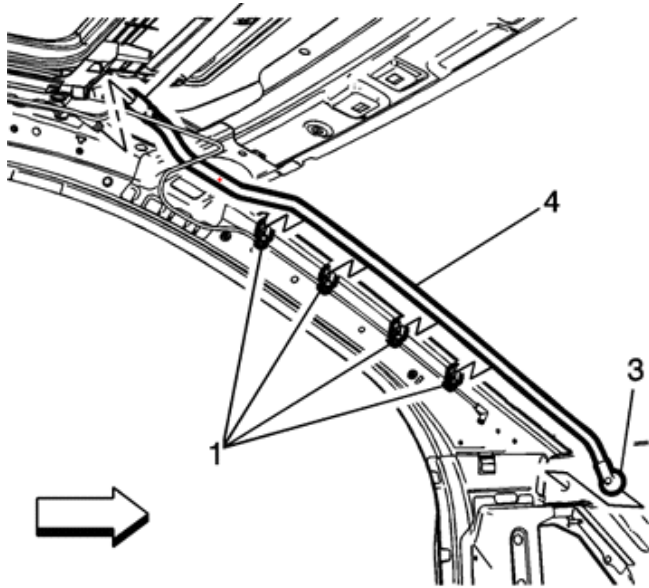
3.3. If the hose seems short or displays a higher level of tension, inspect the hose for proper routing on the affected side. Ensure the hose is not pinched or kinked.

3.4. If the routing appears correct, but the hose still seems to be under tension, TAC advises to try and re-route the hose below the wiring harness (1) to lessen the tension (use tie wraps to re-secure the hose to the vehicle). If the hose is still under tension after re-routing it, replace the drain hose. Refer to EPC for the appropriate right or left drain hose part number. When installing the new hose it is recommended to move it below the harness and secure it with tie wraps if needed.

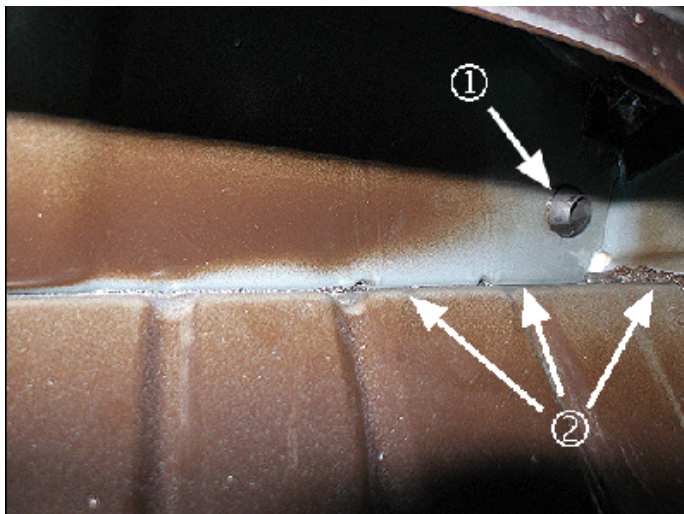
4. If the drain hose and grommets are fully seated water test the cowl by running water along the seam (shown in the graphic below), which runs across the front of the vehicle.

5. If water drips are evident, inspect the seam for voids (2) in the sealer. Clean the affected area and seal the void with Kent High Tech™ Clear Seam Sealer, P/N P10200 (5 oz. tube), or equivalent.
